Geotech Solutions Pty Ltd ABN: 18 125 808 620 P.O Box 4224, Edgeworth 2285 Unit 4/5 Arunga Dr, Beresfield 2322 [P] 0249 494300 [F] 0249 660485 [E] info@geotechsolutions.com.au

25 October 2011

Ashton Coal Operations Pty Ltd PO Box 699 SINGLETON NSW 2330

GEOTECHNICAL ASSESSMENT, IMPACT ON STEEP NATURAL SLOPES ADJACENT GLENNIES CREEK AND HUNTER RIVER BY LONGWALL MINING ULD SEAM

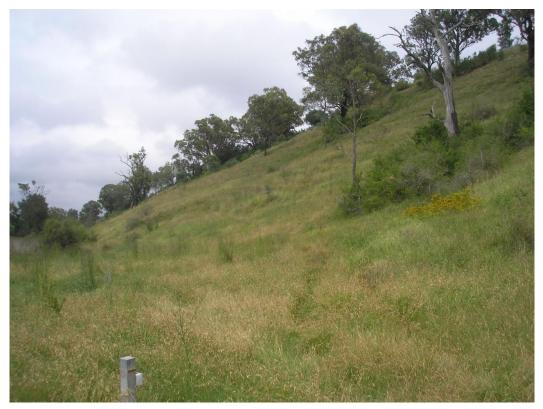
- The steep slope down to Glennies Creek was grass covered with scattered mature trees. Some shallow incised drainage lines ran down the slope.
- The slope has a maximum height of about 40m and the maximum measured slope angle was about 32° (63%).

- There was no evidence of past or existing instability on the slope.

Photograph 1 Looking south at Natural Slope Adjacent Glennies Creek

Infilling and regrading of cracked areas should, however, be carried out post mining to reduce the risk of shallow slumping along steep slopes, in particular the area around the steep slopes adjacent Glennies Creek.

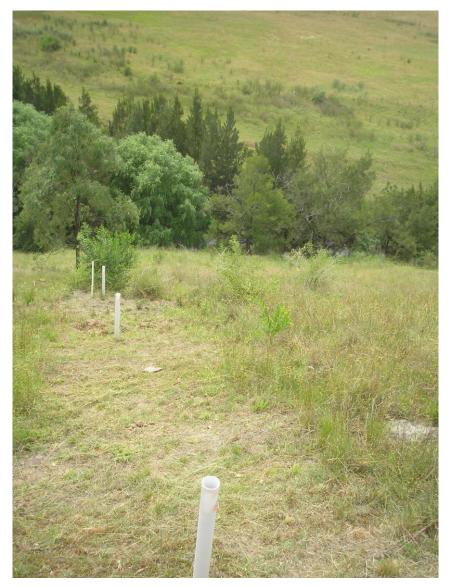
Photograph 2 From Top of Slope Looking Towards Glennies Creek. Pegs are for monitoring ground subsidence movement
