ASHTON LONGWALL 6A – END OF PANEL SUMMARY REPORT**1 INTRODUCTION**

Longwall 6A began extraction on the 6 July 2010 and completed longwall mining on 23 November 2010. Longwall 6A was 1,235m long, 205m wide and was mined without any unexpected impact to the surface environment or infrastructure above it.

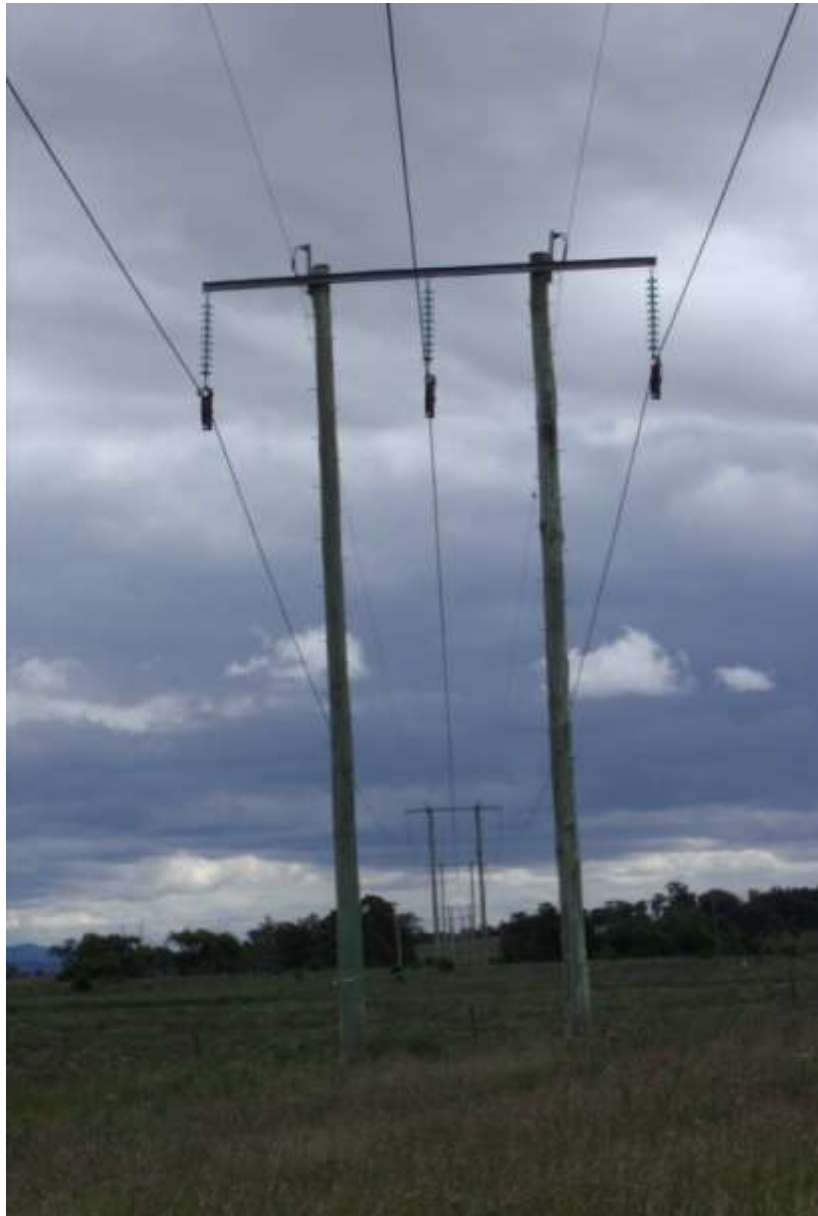
Visual and survey monitoring of the existing 2 pole 132kV power structure over Longwall 6A is undertaken regularly. **Appendix 1, Figure 4** shows the 2 pole structure post stays being fitted. The survey data was recorded and again supplied to the Principal Subsidence Engineer as per the *Ashton Mine Subsidence Monitoring Programme Longwall 5-6*. The effects of subsidence on this structure can be seen in **Appendix 2**. A maximum of 1.41m of subsidence has been recorded on the power poles to date. Monitoring of this power pole set will continue during the first section of Longwall 7A extraction.

Figure 4: 2-pole 132kV power line located mid panel in LW6A (Chainage 985m) looking west from 05/04/2011.

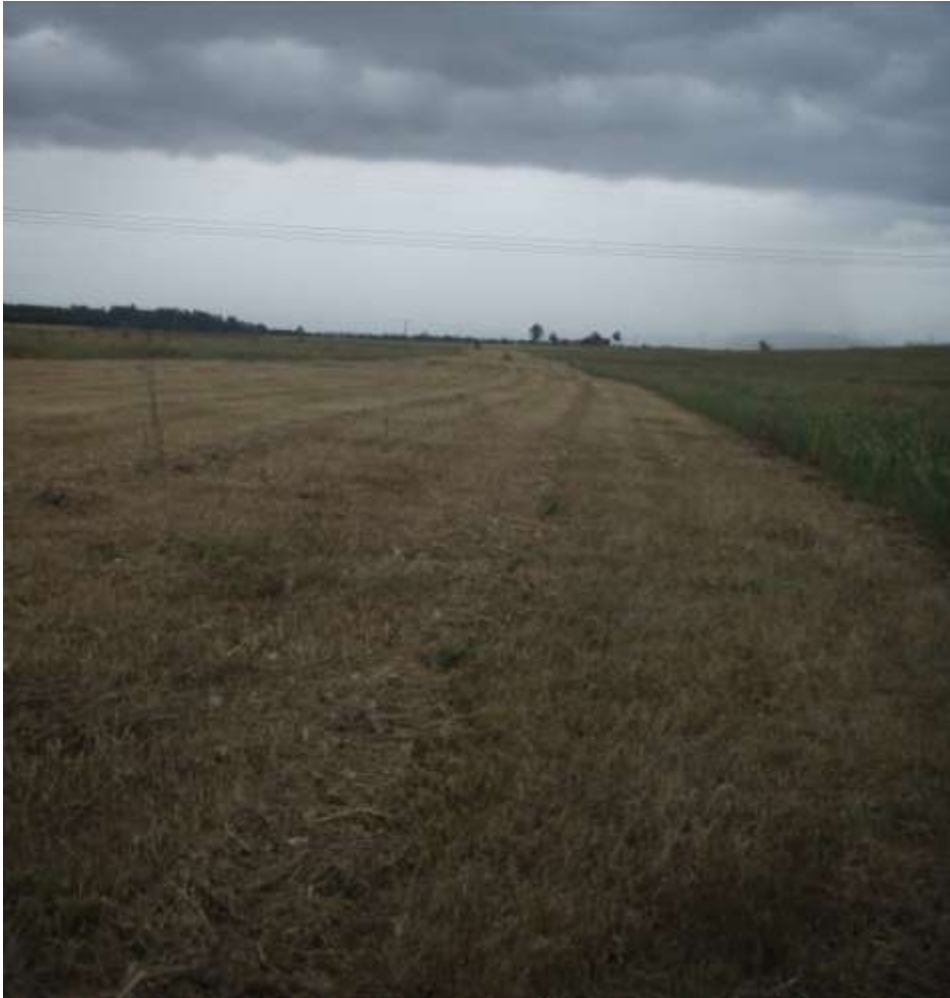
Figure 5: Location of gateroad cracking looking north. Gateroad cracking over the Maingate was concealed by heavy grass growth. Slashing occurred prior to remediation to help locate all gateroad cracks in the area.

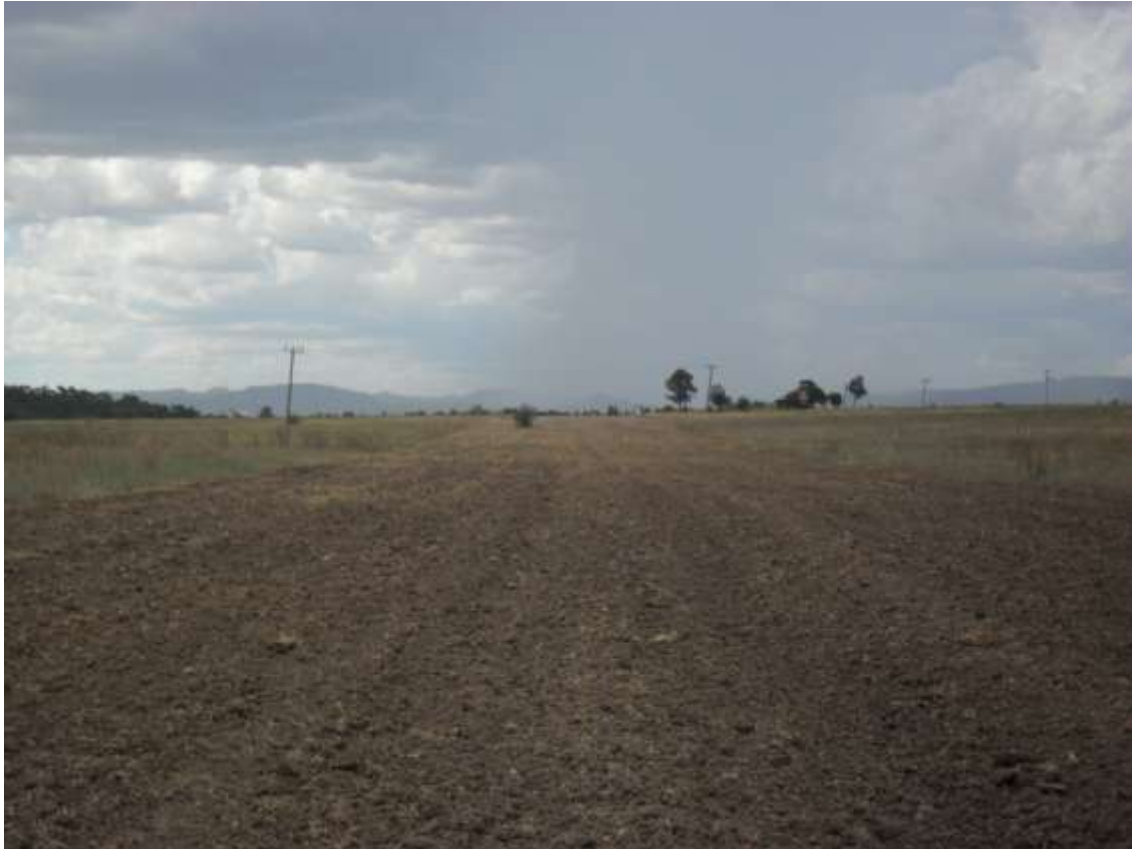
Figure 6: LW6A gateroad post remediation on 02/02/2011. This view looks north at the flat and compact surface post ripping, rolling and harrowing (Ref: **Figure 5**).

In most places, these cracks have been rehabilitated by ripping the surface using a D7 bulldozer to reduce surface water ingress and reduce the risk of injury to stock. Following ripping the surface was bladed off. For Longwall 6A remediation ACOL chose to trial the effectiveness of a **pad-foot roller** on the ripped areas. The roller re-compacted the ripped areas with numerous environmental, safety and operational benefits. The results of this were positive with the surface being returned to a smooth, hard state. To improve regeneration of grass in the area, the rolled areas were harrowed off. Rolling of ripped areas also has ongoing benefits of allowing secondary cracking to be easily identified. Prior to rolling, identifying such cracks was extremely difficult as the surface was scoured.

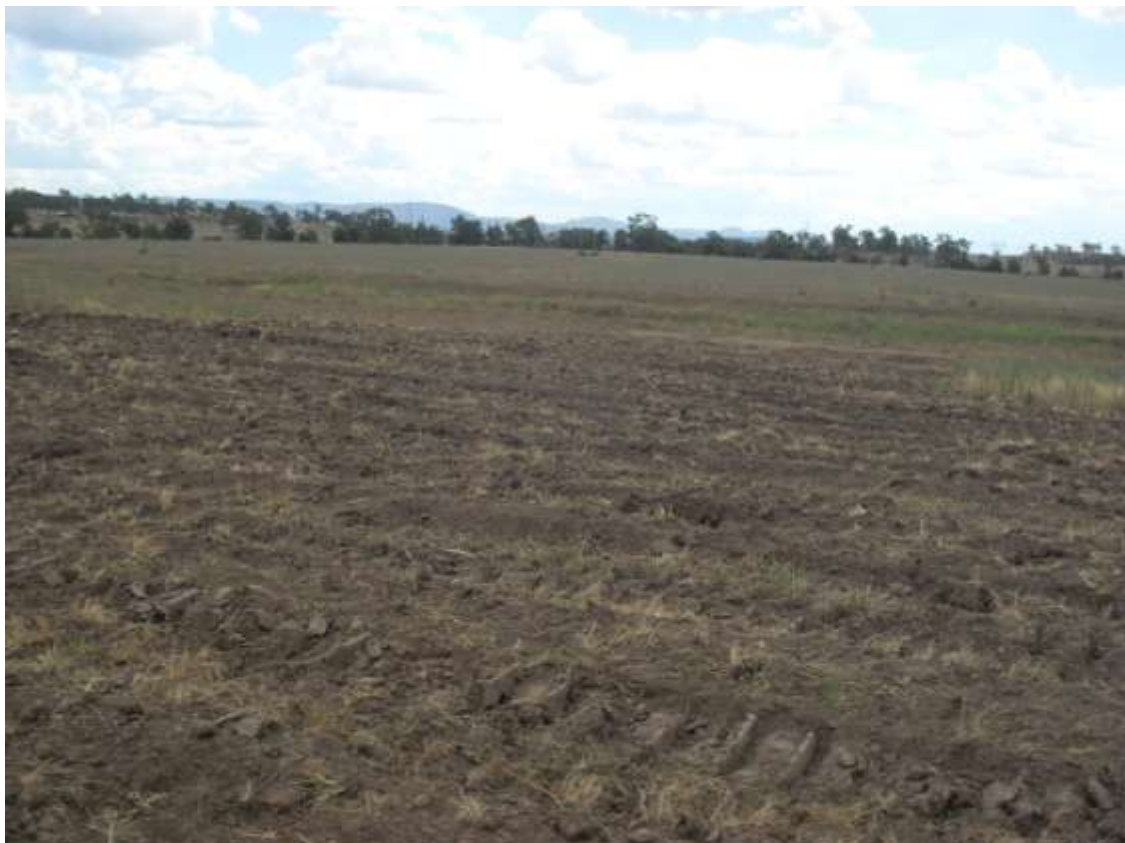
Initial caving over the start of Longwall 6A was typical of the caving behaviour observed elsewhere at ACOL and consistent with predicted subsidence behaviour. No crack was observed over the LW6A start line however a trough formed. Remediation of this trough involved ripping, rolling and harrowing. **Figure 7** shows the finished remediation of the start line trough. Post LW5 remediation (as reported in the LW5 End of Panel report) cracking was found over the Longwall 4 take off roadway. This was pegged and marked with 'caution tape'. Remediation of this crack occurred during LW6A remediation. Remediation involved compaction of the crack edges into the crack so that the surface was relatively level again. No ripping occurred in this area due to its proximity to some Archaeological sites. Due to the shallow depth of the crack, this method of remediation has proved positive.

Figure 7: LW6A start line remediation post remediation on 02/02/2011. This photo looks from the tailgate corner to towards the centreline (south-west).

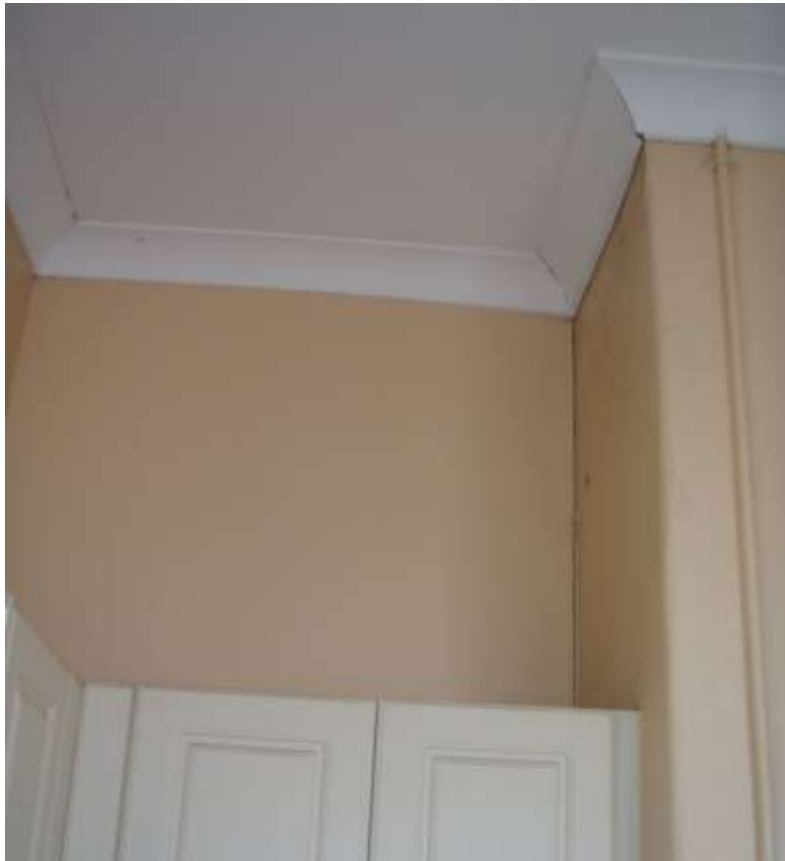
Longwall 6A undermined an unoccupied ACOL dwelling known as the 'Yellow house'. Visual inspections on this dwelling prior to, during and post undermining were recorded in accordance with standard visual subsidence inspections. The dwelling's condition post undermining has remained relatively unchanged with some doors now 'sticking' and some small cracking evident between the roof and wall cornice as shown in **Figure 8**. No repair work is planned on this dwelling due to it not being re-occupied in the foreseeable future.

Figure 8: Cracking between the wall and cornice in the 'yellow house'. The shown cracking is the worst observed from within the dwelling post subsidence.

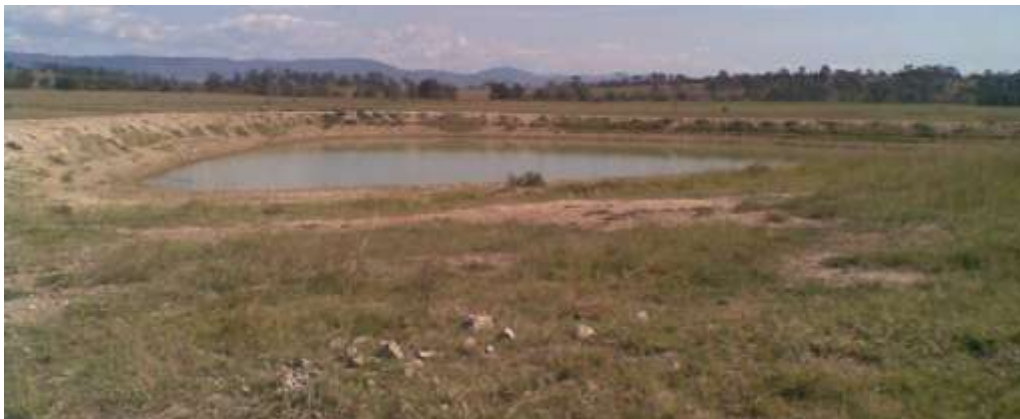
Two farm dams were undermined during Longwall 6A extraction. Both dams were drained prior to undermining in accordance with ACOL's Surface Water Dams Subsidence Management Plan. Following undermining both dams refilled to previous water storage levels. Dam 10 (small dam) had no visible subsidence damage. The profile formed by subsidence has increased this dam's storage area. Currently this dam is full to capacity. Dam 11 (big dam) was observed to have cracking through the walls and floor as the longwall passed beneath it. Cracking then closed up as the ground settled due to this dam being predominantly located mid panel. Following full subsidence, two holes remained in the top of the dam wall. These remnant gateroad cracks were remediated along with the dam wall being re-profiled. Re-profiling was required to create an over-flow around the side of the dam wall rather than over the centre of the wall. This issue was present prior to undermining as shown in **Figure 9**. Post remediation images are attached in **Figure 10**.

Figure 9: Dam 11 located above the LW6A panel pre undermining on 22/04/2010. The photo was taken looking south west at the centre of the dam wall which is also the lowest point.

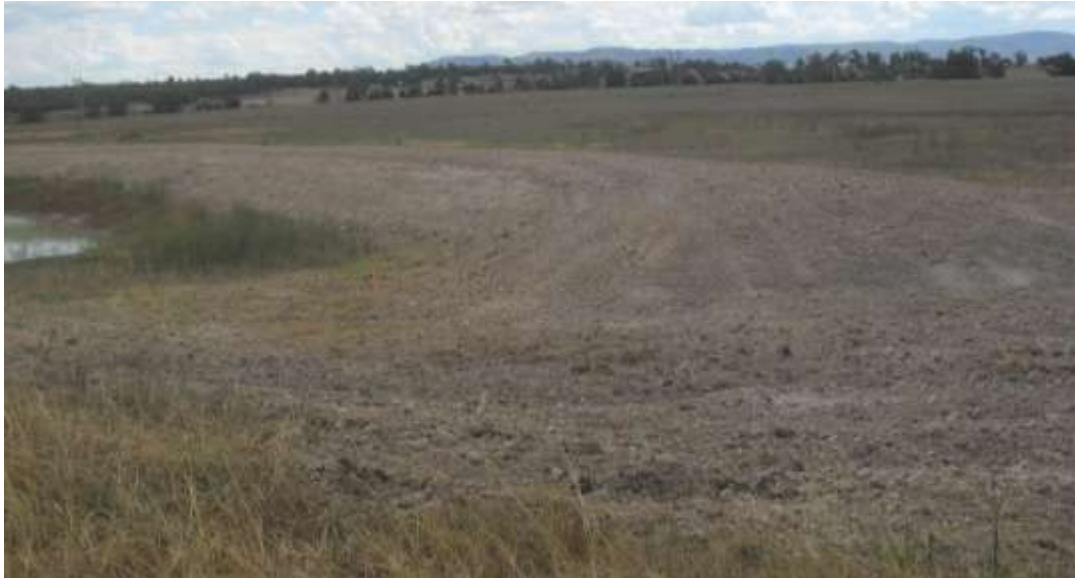
Figure 10: Dam 10 post wall re-profiling. The dam wall was re-profiled so that the lowest point of the dam was again the spillway as designed. This was taken on the 02/02/2011 and is looking south-south west (Ref: **Figure 9**).

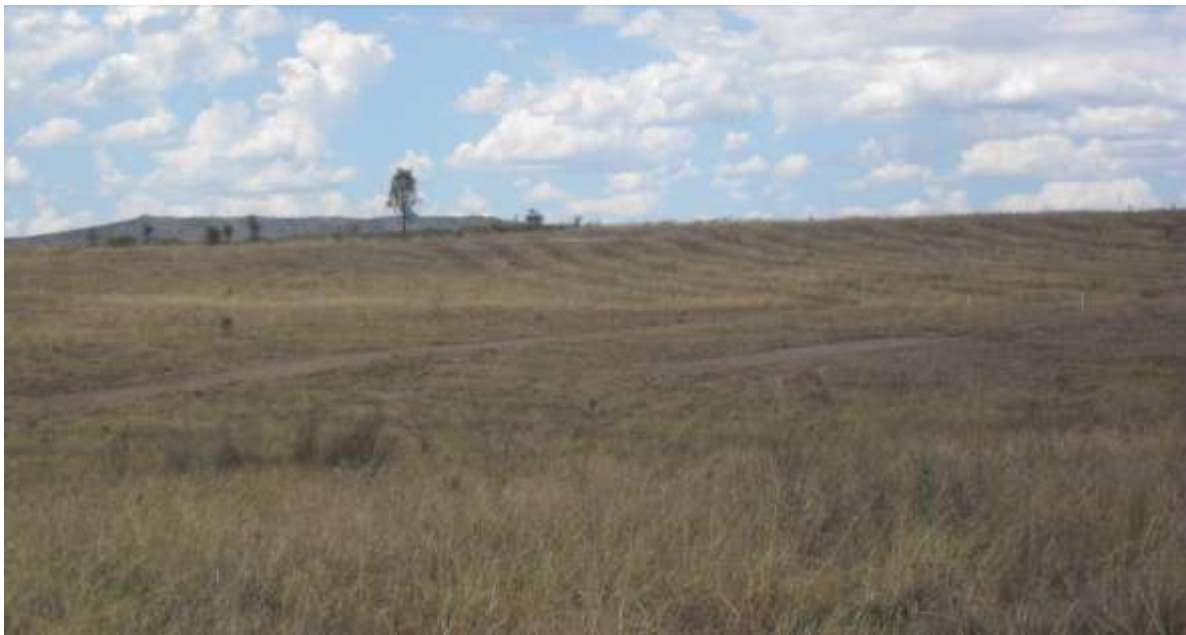
Figure 11: Longwall 3 end line cracks post remediation on the 02/02/2011. The bare patches are where the crack once existed. This image is looking to the north.

Whilst machinery was on site to repair the LW6A cracking, some remnant cracking over the Longwall 3 and Longwall 4 end lines was repaired. Rather than ripping the cracks, ACOL trialled a new remediation technique which rolled the edges of the crack into the crack. The cracking repaired by this method were primary cracks and had not been remediated previously. The result of rolling was positive with the final ground surface being flat and smooth in comparison to ripping. Due to this technique increasing the remediation quality, all areas ripped over LW6A were rolled and harrowed. **Figure 11** shows the result of rolling and harrowing the LW3 end line cracks. Post remediation results has shown a visual increase in grass growth and an increase in safety for personnel, stock and native fauna as the surface is relatively flat and not rough to travel over. Rolling of cracks is only suitable for shallow cracks due to the limitations of compaction with the roller. For deeper cracks ACOL plans to continue ripping and again follow up by rolling the ripped areas flat as in Longwall 6A remediation.

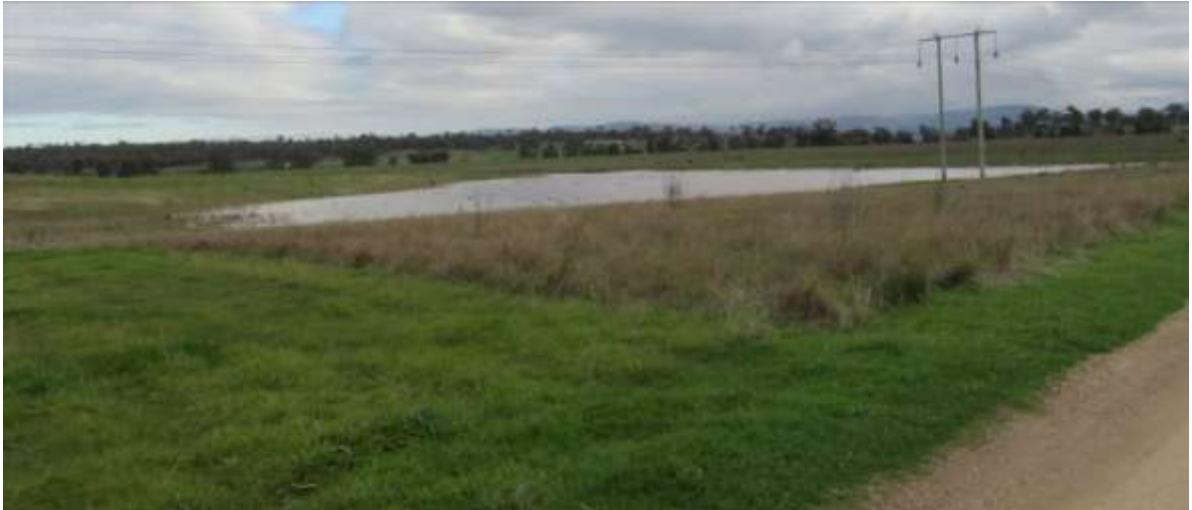
Ponding over Longwall 3 (at chainage 530m) has been left as a water storage area. Because of its size and tendency to fill after rain events repair will not occur. Other areas where ponding has become evident is three zones over Longwall 5 (at Chainage 1,090m, 400m and 80m) and Longwall 6A (at Chainage 2,360m and adjoining Dam 10). Ponding above LW6A above Dam 10 is shown in **Figure 12**. All areas of ponding currently pose no safety or environmental issues however will need to be pumped out or have natural drains re-established to prevent continual filling and holding. This is planned as future remediation.

Figure 12: Ponding over LW6A post a rain event on the 16/06/2011. This has filled Dam 10 to capacity with water now occupying a greater area due to subsidence. This image is looking south-south east with the 2-pole 132kV powerline in the background.
