# ASHTON COAL PROJECT

## ANNUAL ENVIRONMENTAL MANAGEMENT REPORT 2014

## Ashton Coal AEMR 2014

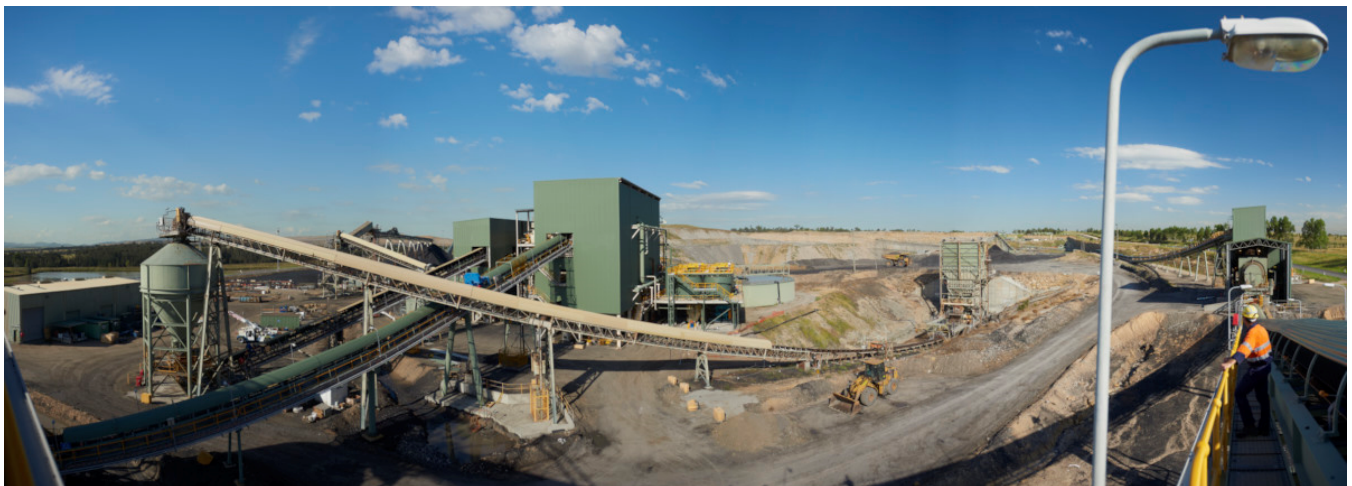
**Figure 2 ACOL's Coal Handling and Preparation Plant**

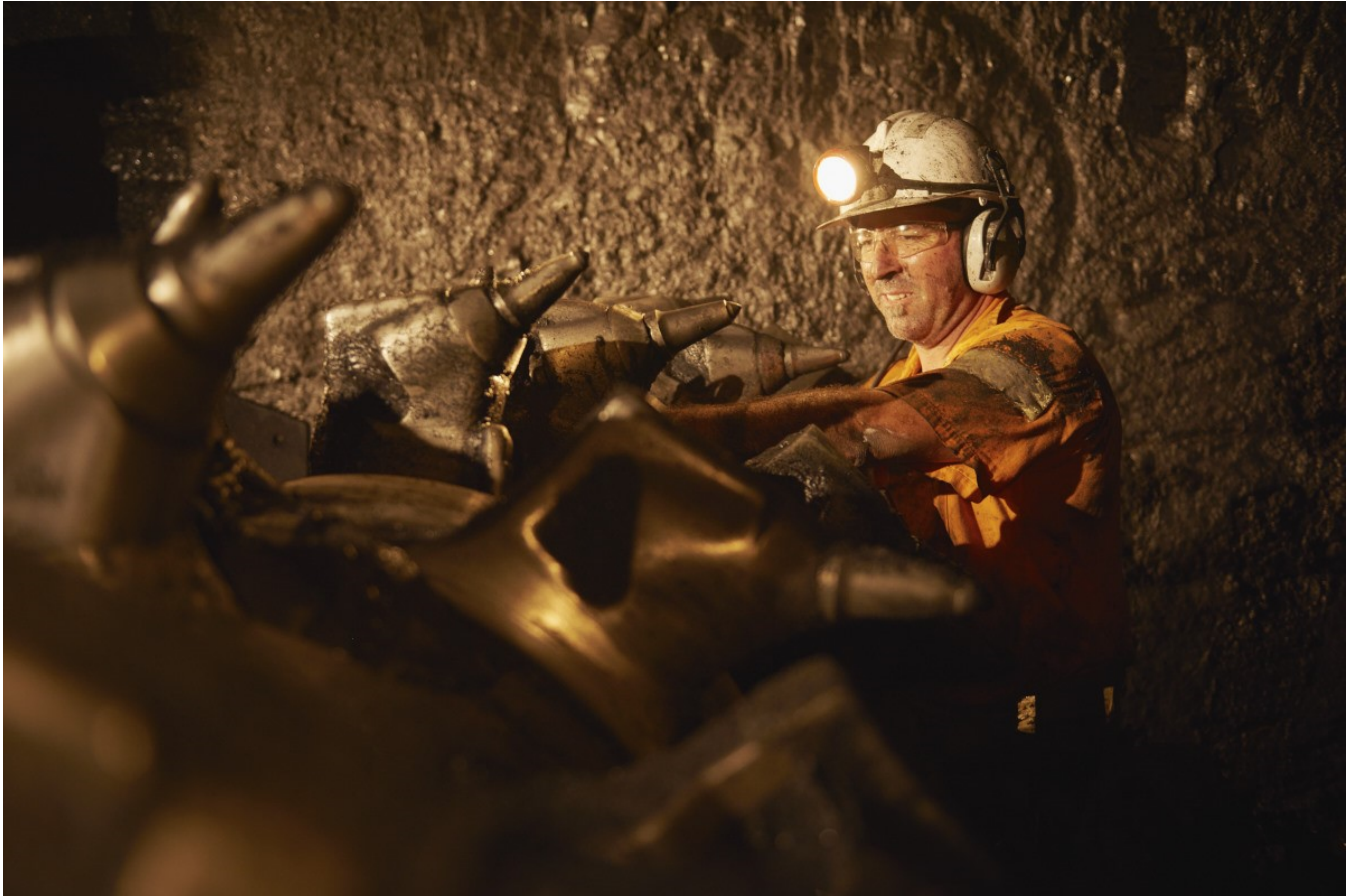
**Figure 3 underground operations.**

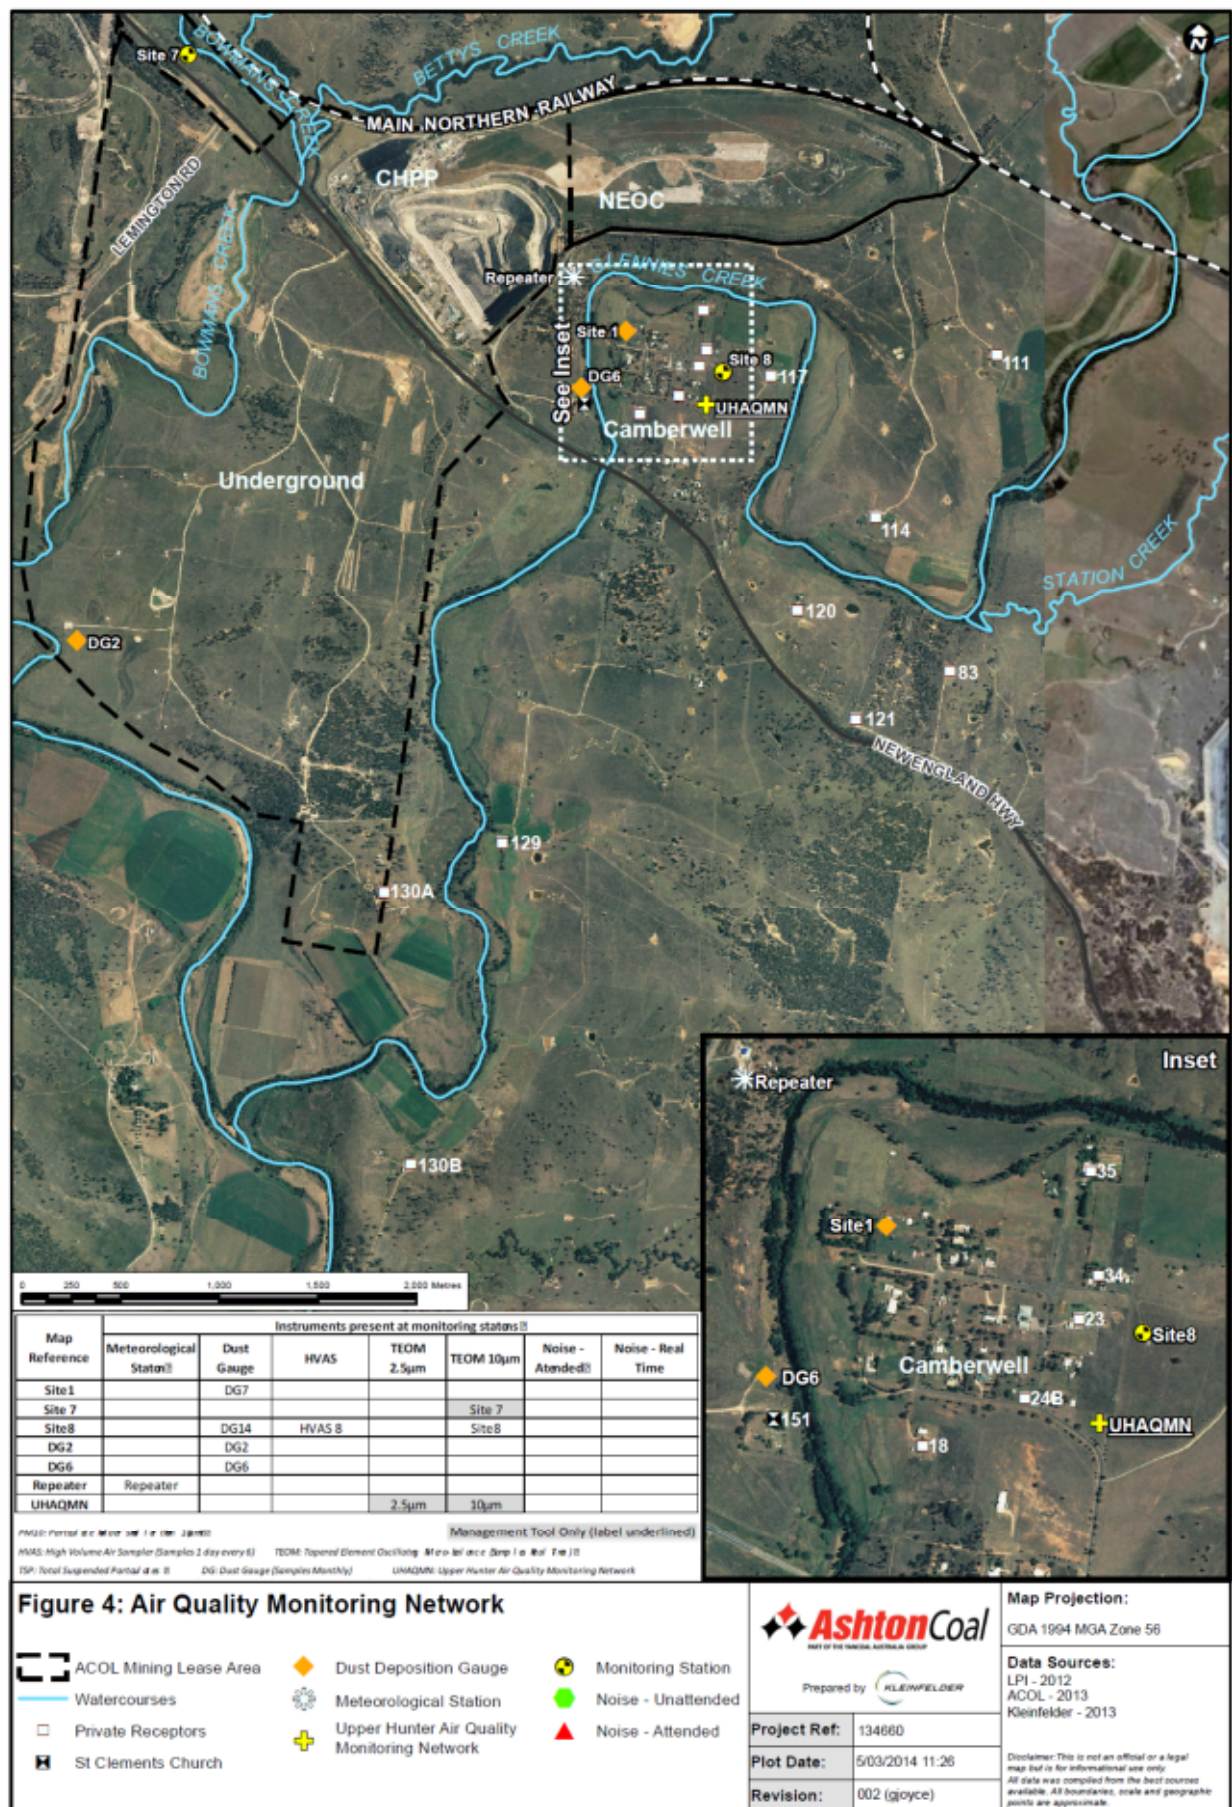
Figure 11: ACOL's meteorological and air quality monitoring locations

The locations of air quality monitoring sites at Ashton Coal are shown in Figure 11.

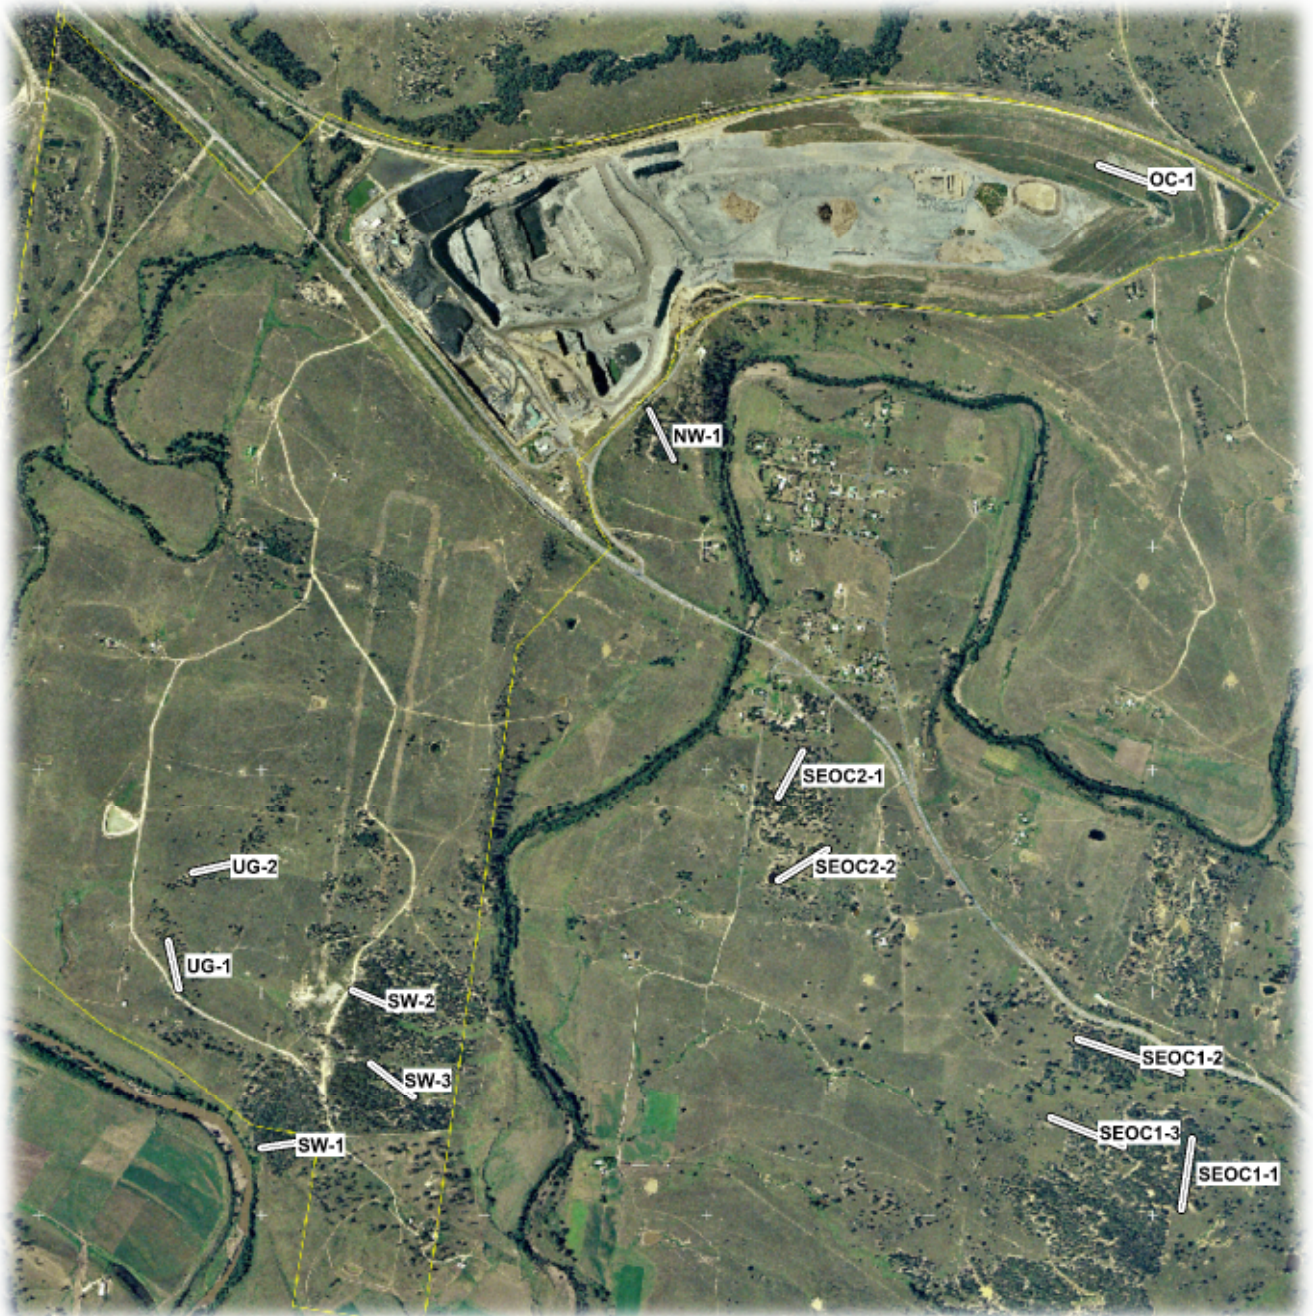
**Figure 22 : Monitoring survey sites used for winter 2014 and summer 2014.**

*SW; Southern woodland, NW; northern woodland, OC; Open cut regeneration area, UG; Underground Area, SEOC1; South east open cut area 1, SEOC2; South east open cut area 2.*

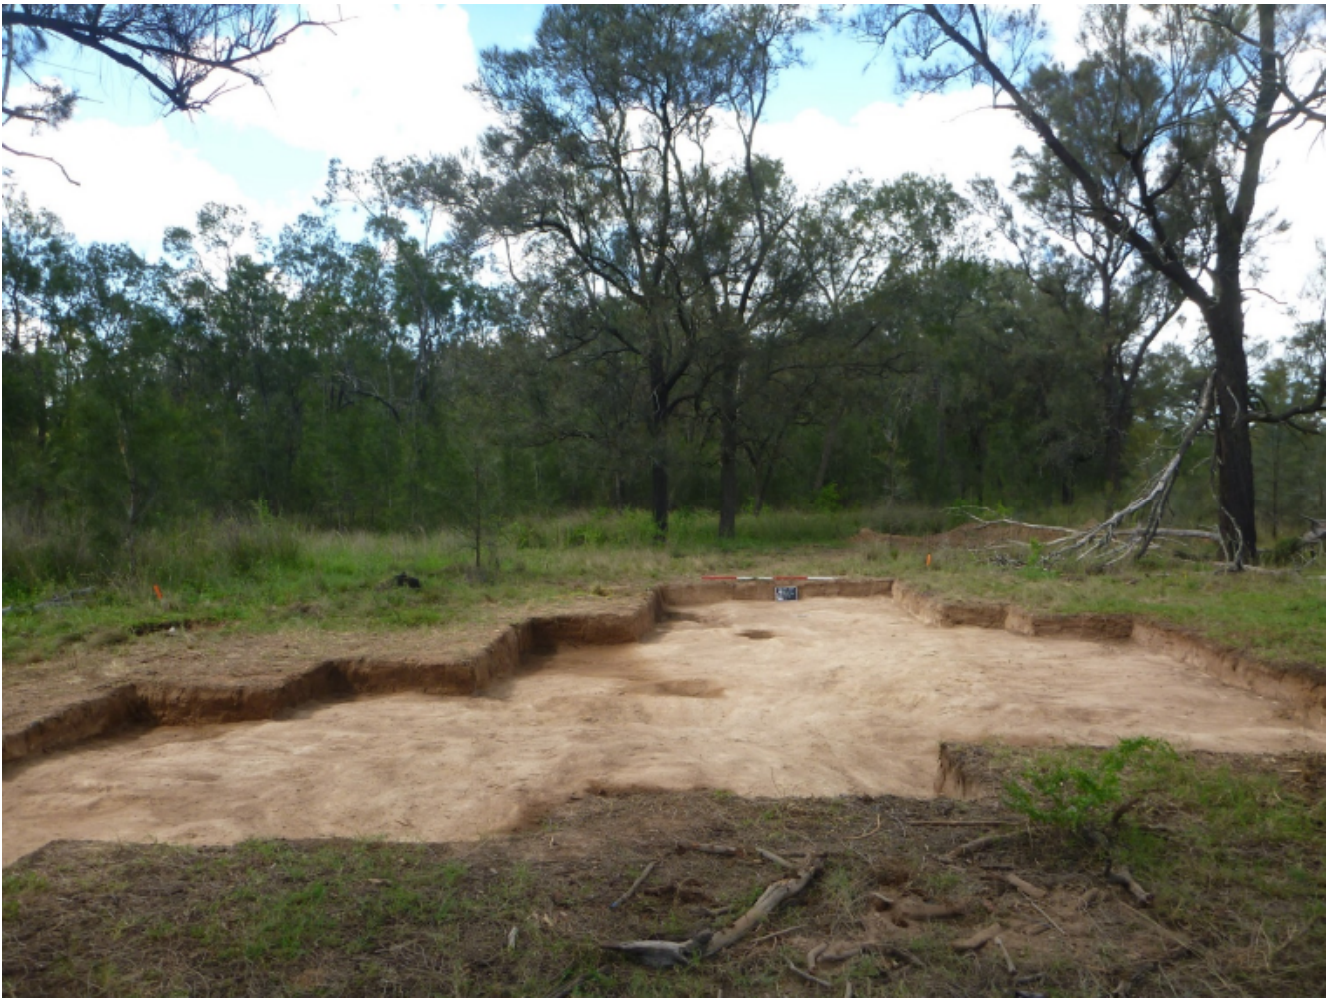
**Figure 28 Oxbow site excavation area - facing east**

- Clean up and disposal: Sweeping up the living space after a period of time has been ethnographically documented for Aboriginal camps. This should result in the redistribution of materials. Throughout the site there were patches of low and high densities of artefacts, residual deposits (including caches), and the disassociation of manufacturing products.
- Heterogeneity of material and artefact types: Over the long term a wide variety of materials can be expected to be brought in and different kinds of tools made, some of which would escape cleaning up. Use-wear on flake platforms (resharpening flakes) and edges on small tools were frequent.

Following the salvage mining has occurred in LW103 and it is anticipated that parts of the Oxbow Site may experience subsidence in 2015.

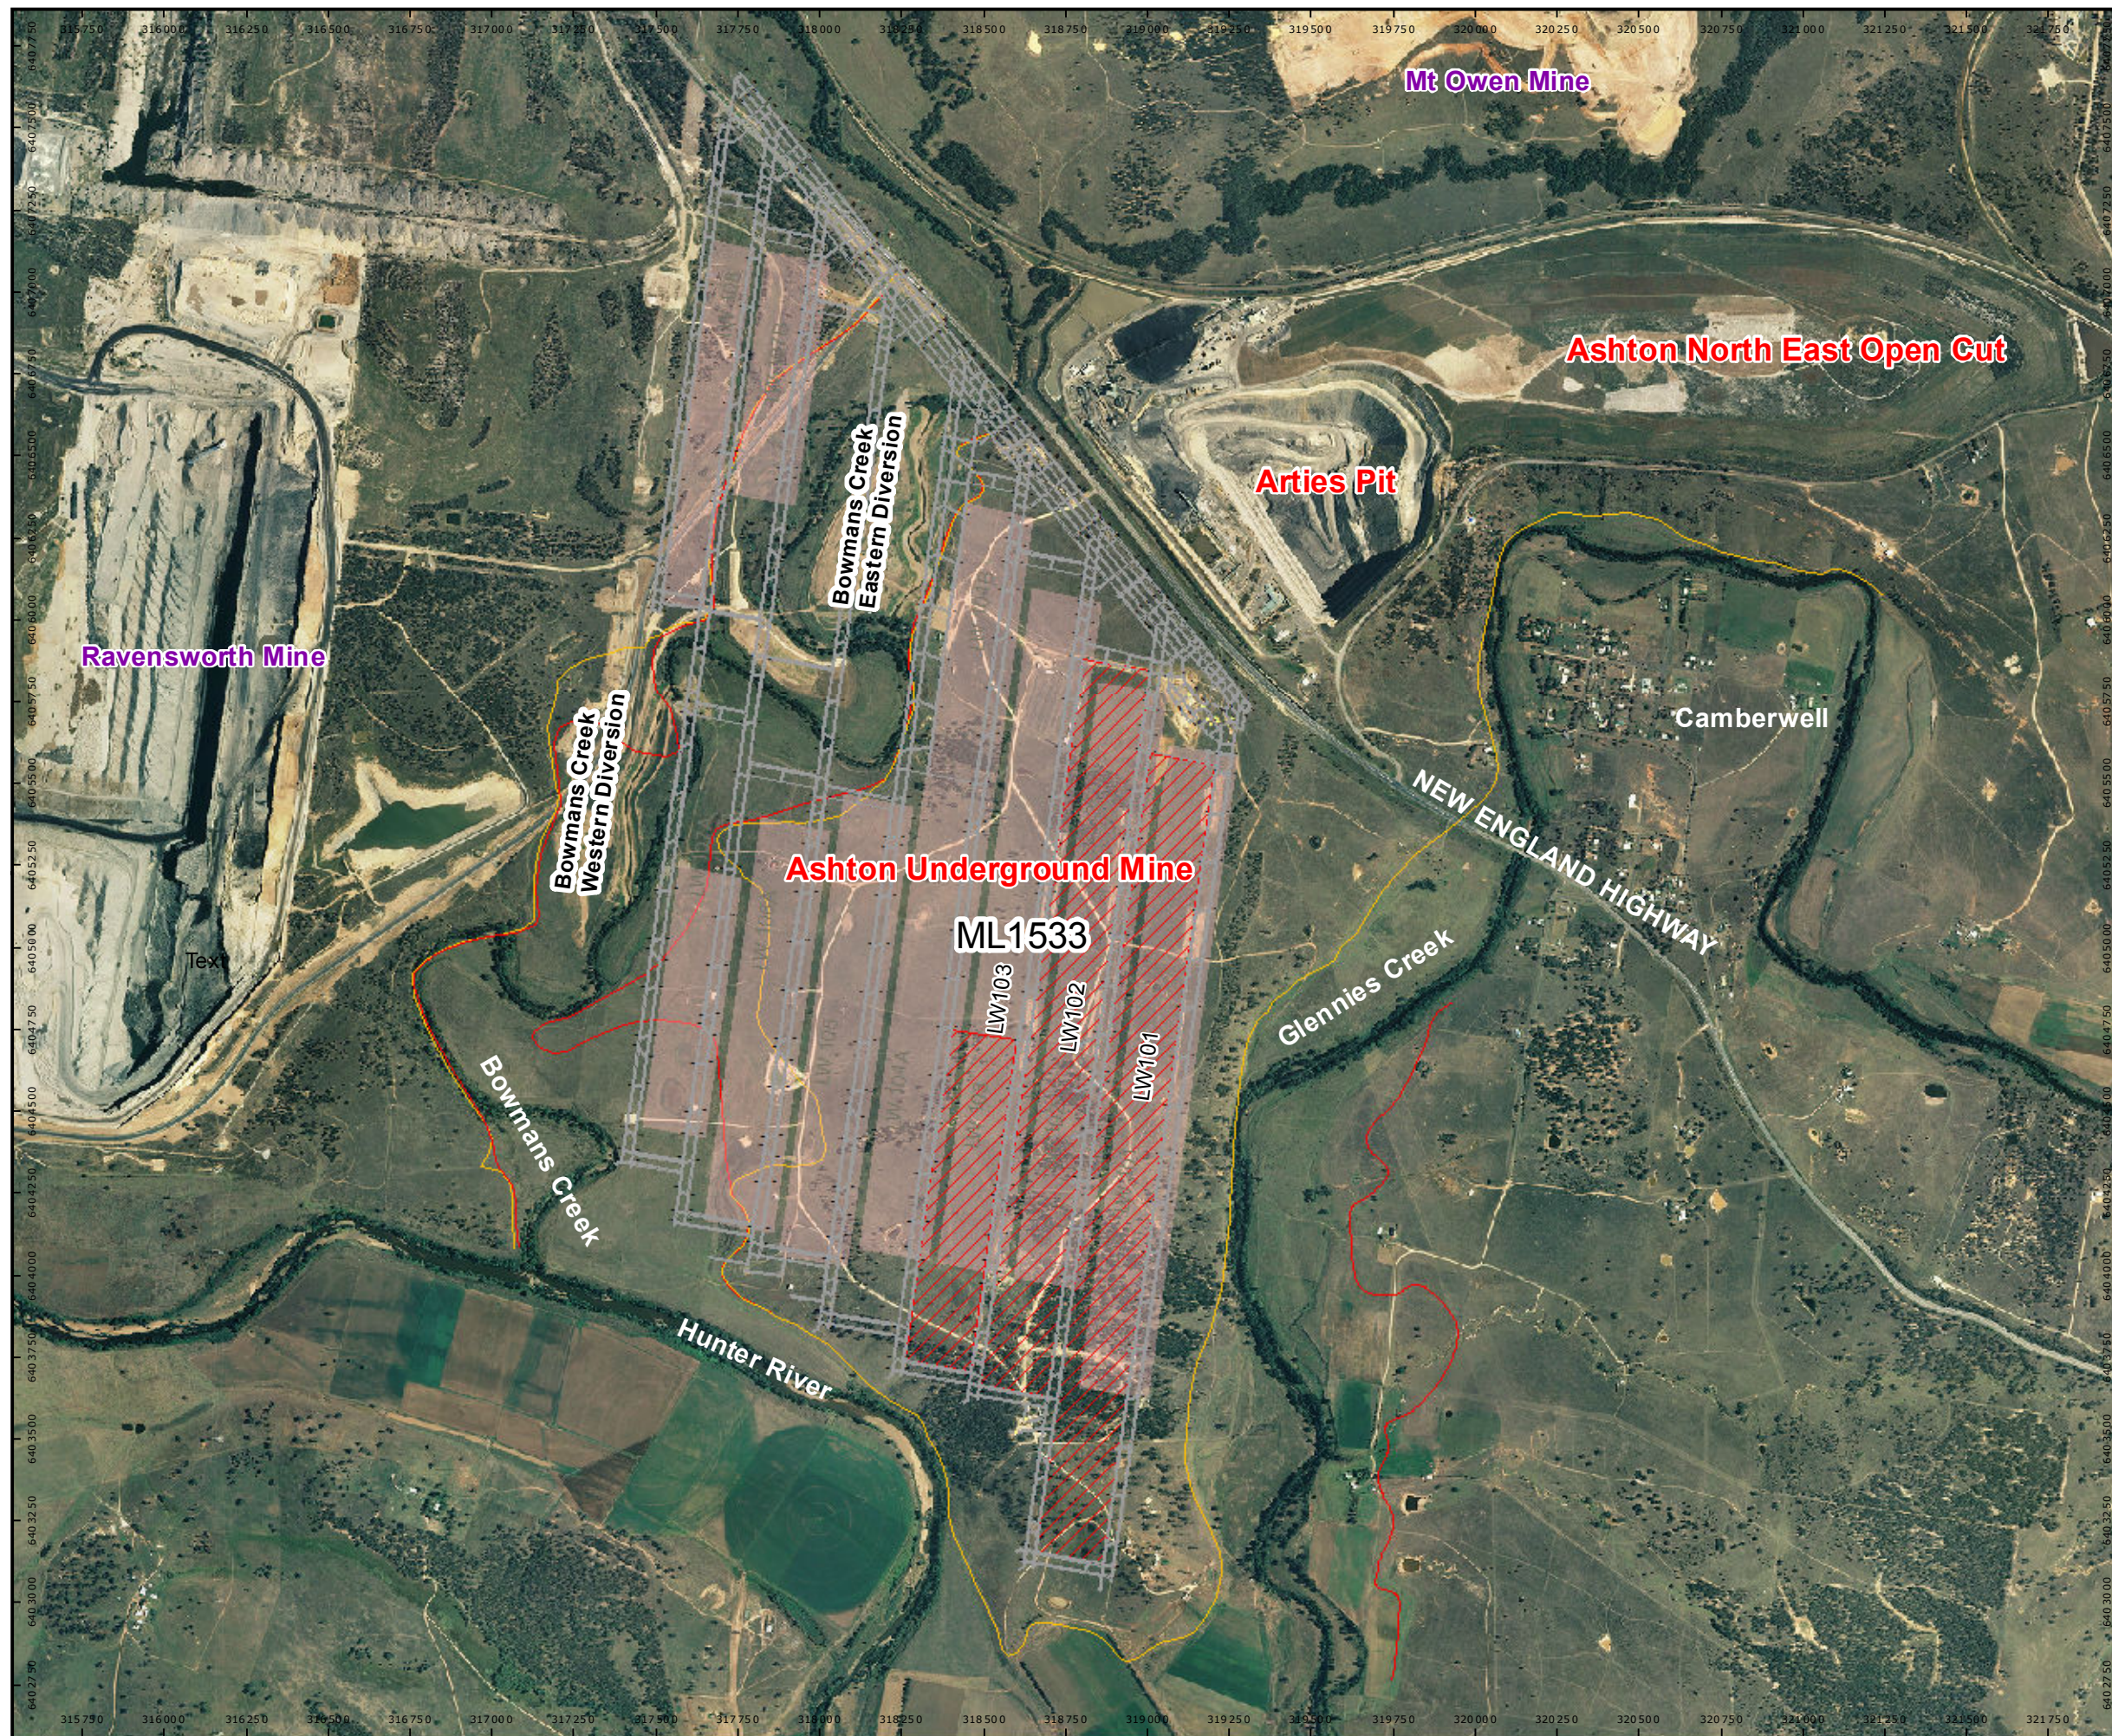
FIGURE 1

- Underground Mine Workings
- Alluvium boundary
- Saturated alluvium boundary
- ULD Underground Mine Plan
- Pikes Gully Seam Extraction
- ULD Seam Extraction

#### Ashton Project Area

- Saturated quaternary sediments (alluvium) including:
  - Bowmans Creek Alluvium (BCA)
  - Glennies Creek Alluvium (GCA)
  - Hunter River Alluvium (HRA).
- Shallow Permian sandstone and minor coal seams referred to in this report as coal measures overburden (CMOB).
- Permian coal measures of varying thickness targeted by mining.
- The identified Groundwater Dependent Ecosystem (GDE), a river red gum population shown in Figure 1.

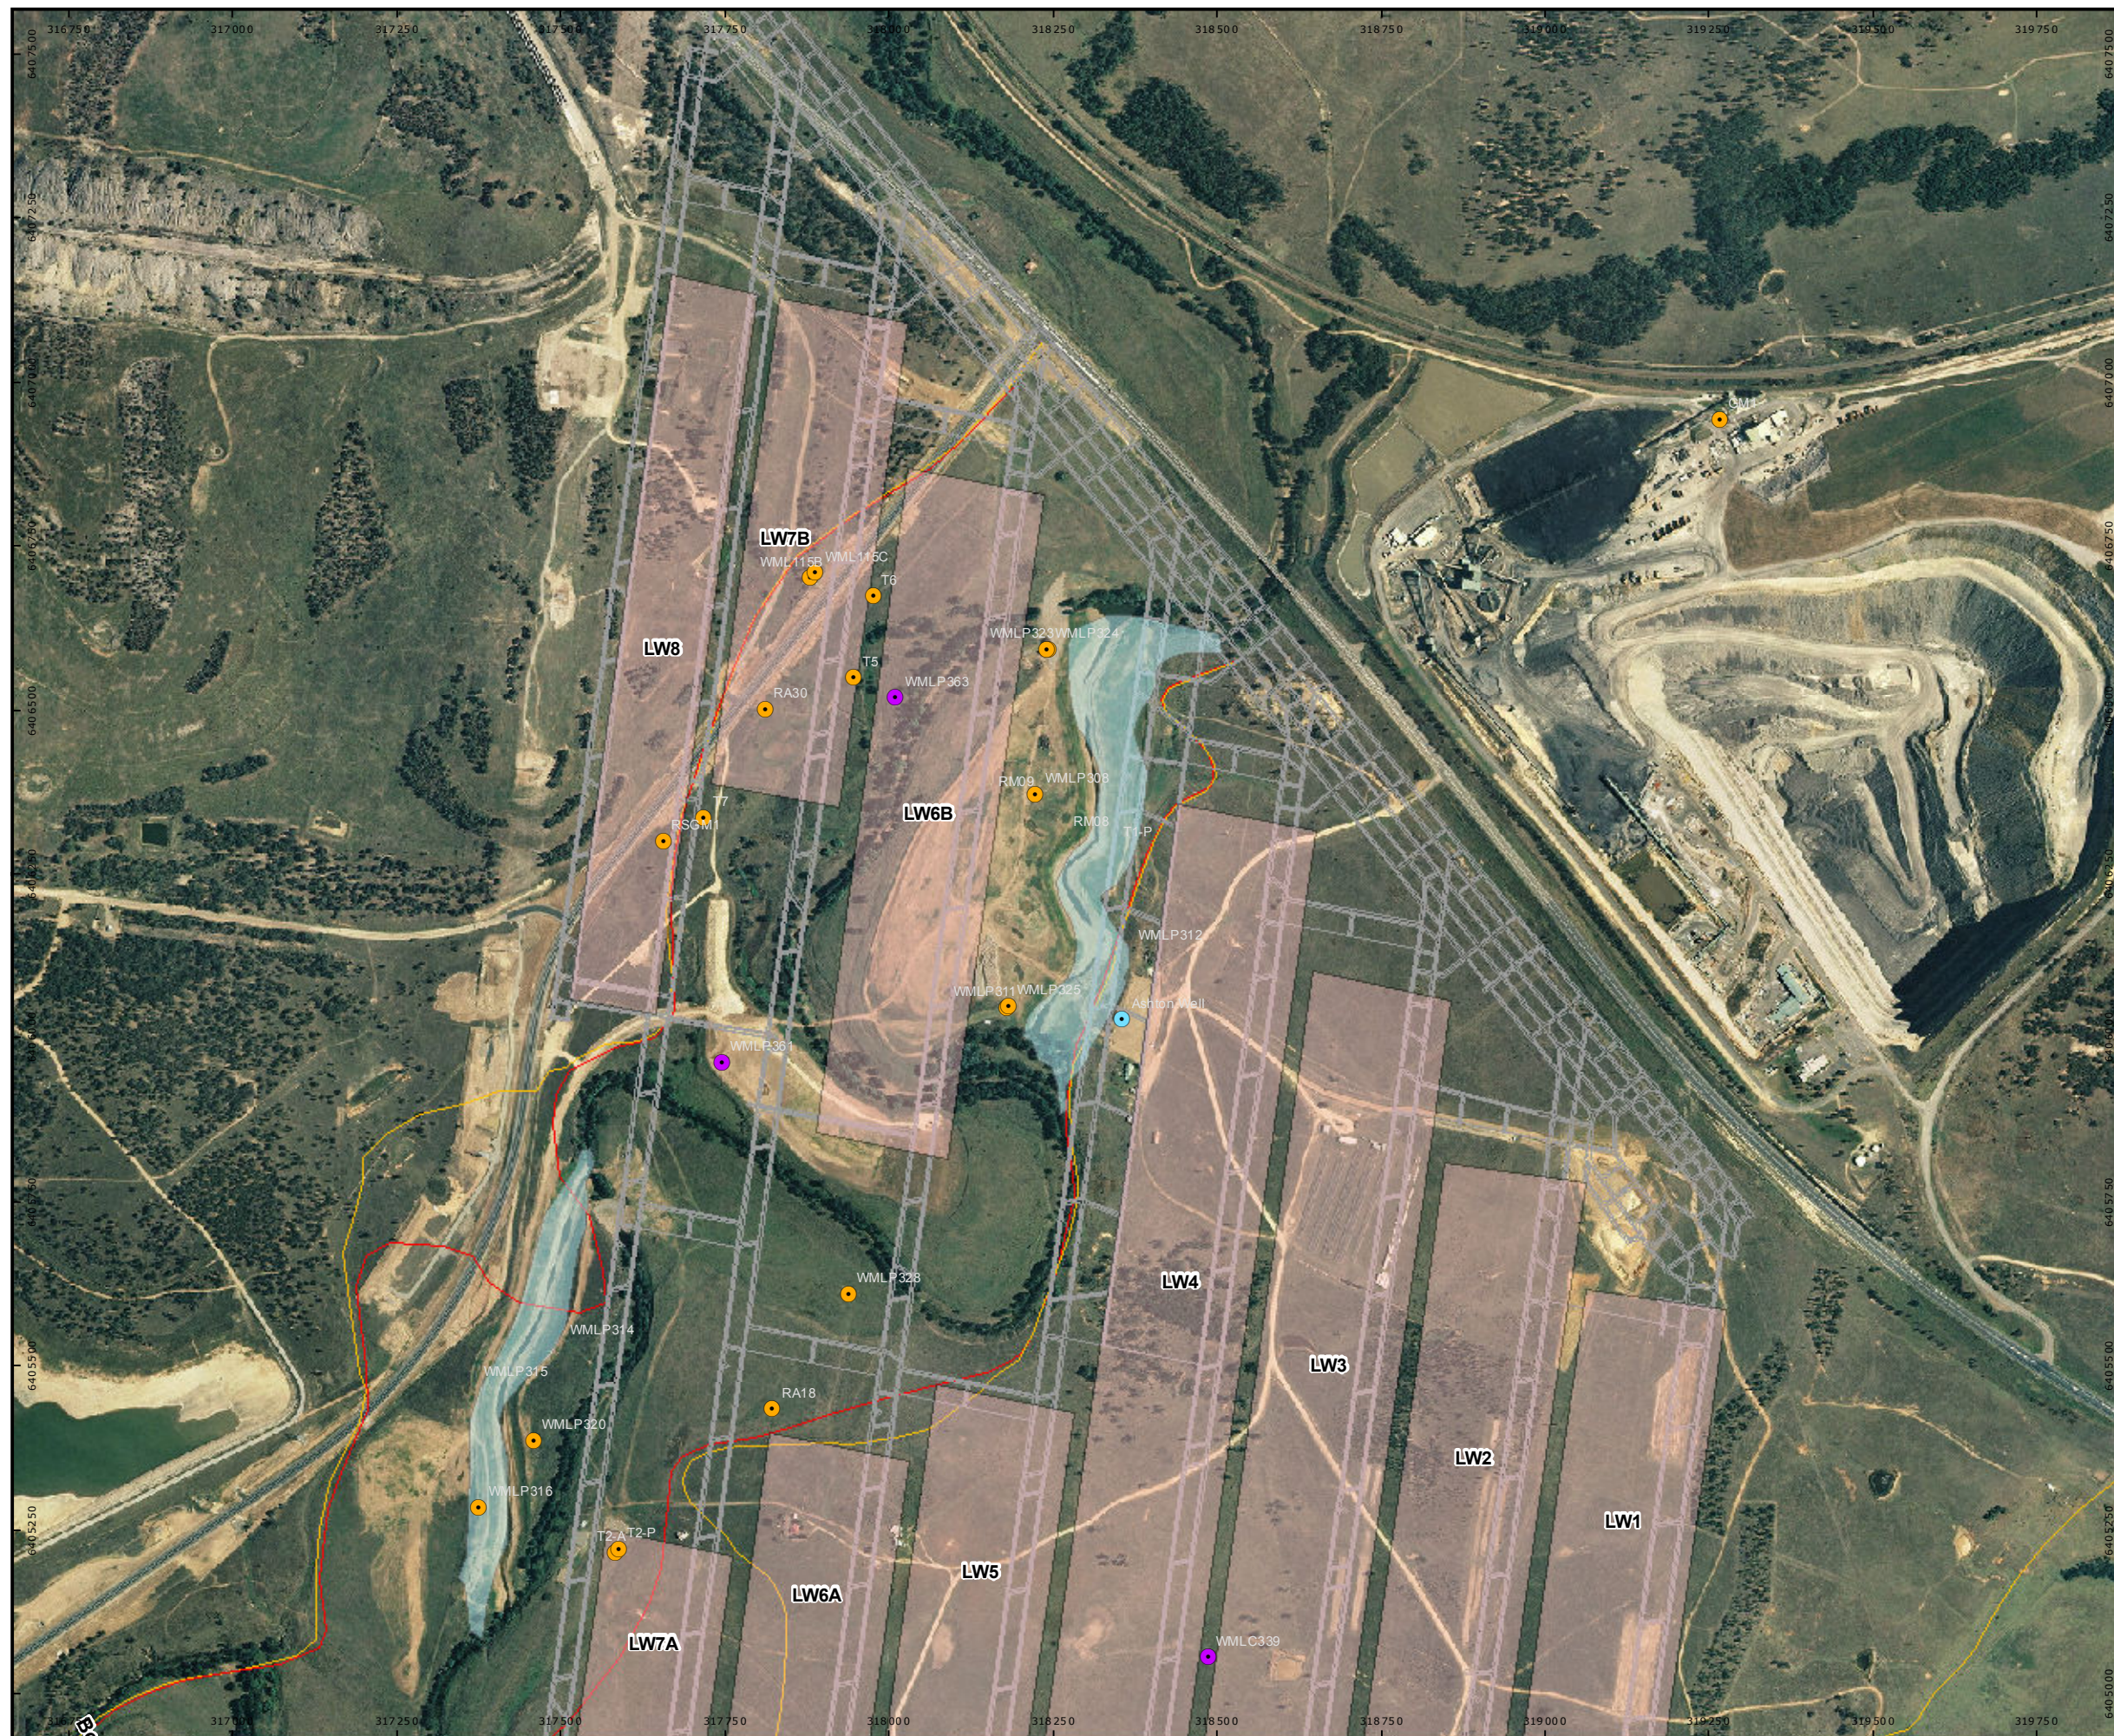
No	Description	No.	Description
Underground mining equipment			
4	12CM 12 Continuous Miners	8	PJB Mk4.5
4	10SC32 Shuttle Cars	8	Juganaut V2
4	21m <sup>3</sup> /s auxiliary ventilation fans	1	Flakt Woods 110kW centrifugal fan
4	1000 cfm air compressors	2	Flakt Woods 315kW centrifugal fans
2	1050mm temporary conveyors (Jiffy drivers)	3	1400mm conveyors (two VVVF drives each)
5	1600mm Conveyors (two VVVF drives each)	1	1600mm stacker conveyor (single VVVF Drive)
1	Mittsui Road Header	1	10t telescopic fork lift

## 2.5 Mineral Processing

Piezometer ID	Piezometer Type	Monitored Strata and Hydrograph Reference
<b>LW102/LW103 – Upper Liddell Seam (see Figure 3 and 4)</b>		
WML120B	Standpipe	Glennies Creek Alluvium – Figure 10
WML247	Standpipe	
WML239	Standpipe	Glennies Creek Alluvium – Figure 11
WML240	Standpipe	
WML129 <sup>1</sup>	Standpipe	Glennies Creek Alluvium – Figure 12
WMLP336 <sup>1</sup>	Standpipe	Hunter River Alluvium – Figure 13
WMLP337 <sup>1</sup>	Standpipe	
WMLP338 <sup>1</sup>	Standpipe	
WML119	Standpipe	Pikes Gully seam – Figure 20
WML181	Standpipe	
WML182	Standpipe	
WML183	Standpipe	
WML184	Standpipe

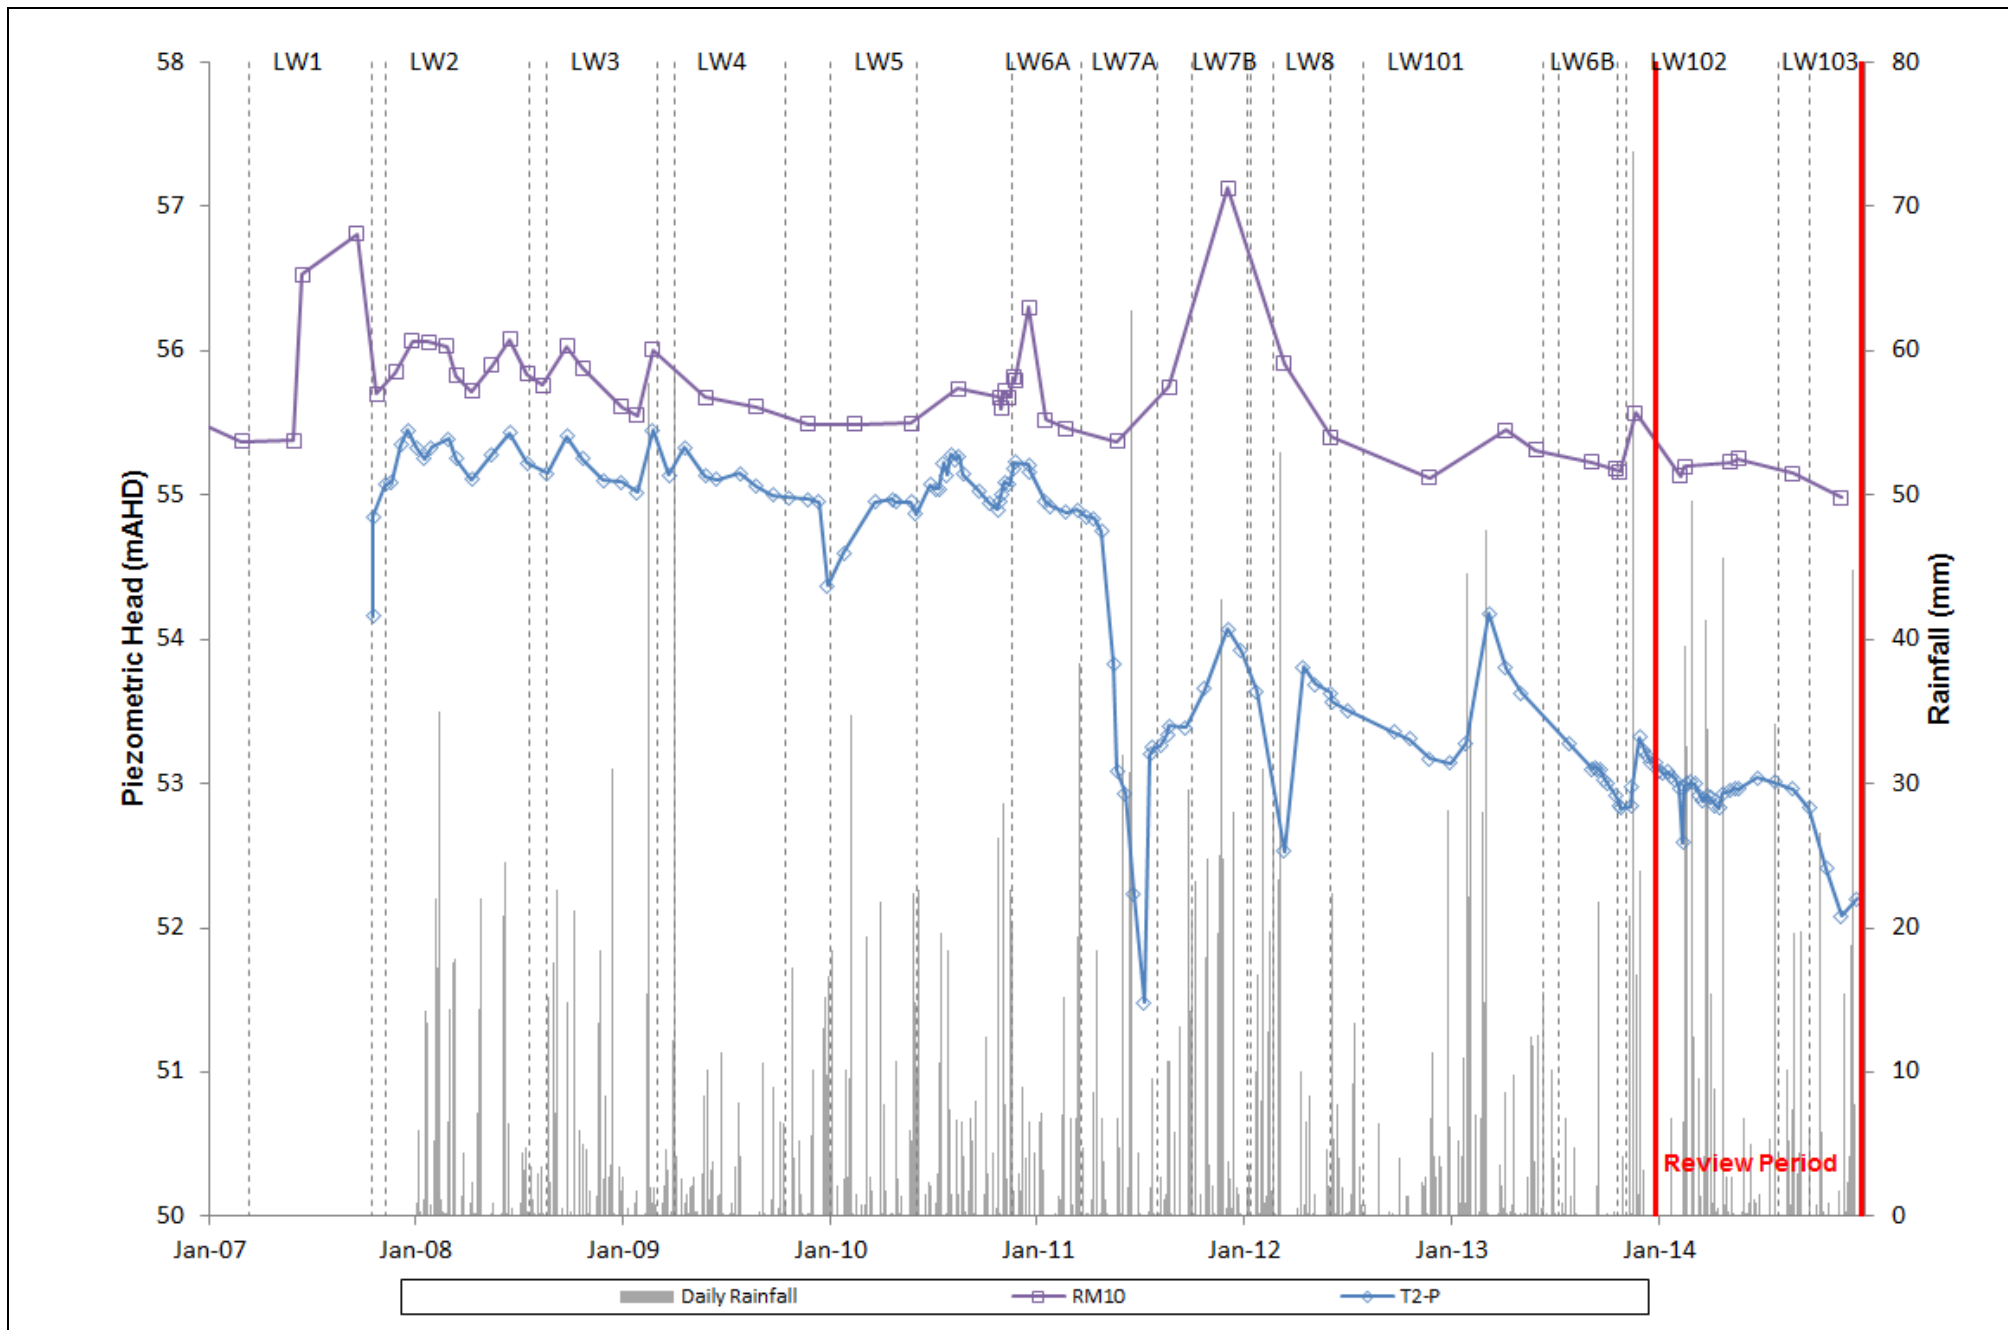
HYDROGRAPH – COAL MEASURES OVERBURDEN (CENTRAL) FIGURE 15

### Central Underground Area – Figure 15
