Soils, Agricultural Suitability and Land Capability

South East Open Cut Project
&
Modification to the
Existing ACP Consent

Soil, Land Capability and Agricultural Suitability Report

Version: Second Draft
Department of Lands
Soil Conservation Service
Scone Research Centre
30 July 2009

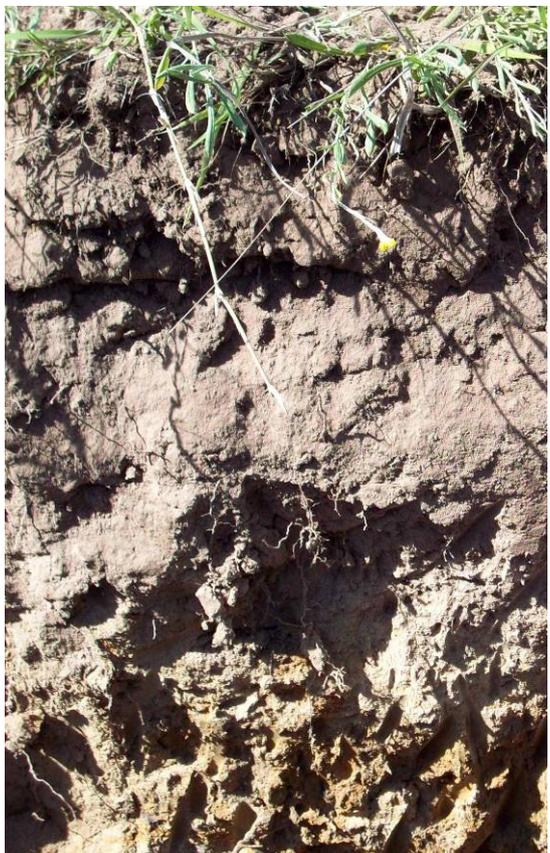
Plate 2. Soil test pit 88.

Bleached-Mottled Brown
Chromosol (upper slope)

B2 - yellowish brown medium
heavy clay

C - weathered sandstone
(coarse)

A moderately acidic, dark greyish brown, sandy clay loam A1 horizon and a pale brown bleached A2 horizon typically formed the topsoil of the Bleached-Mottled Brown Chromosol. The subsoil was yellowish brown, medium clay with orange and grey mottles, characteristically indicative of impeded drainage through the subsoil.

Test Pit 88 Landform: Upper slope (7%) westerly aspect
Soil classification: Sodic Bleached-Mottled Brown Chromosol (Dy4.42)
Location: Eastern, timbered area (321280E 6403444N)
Surface condition: soft

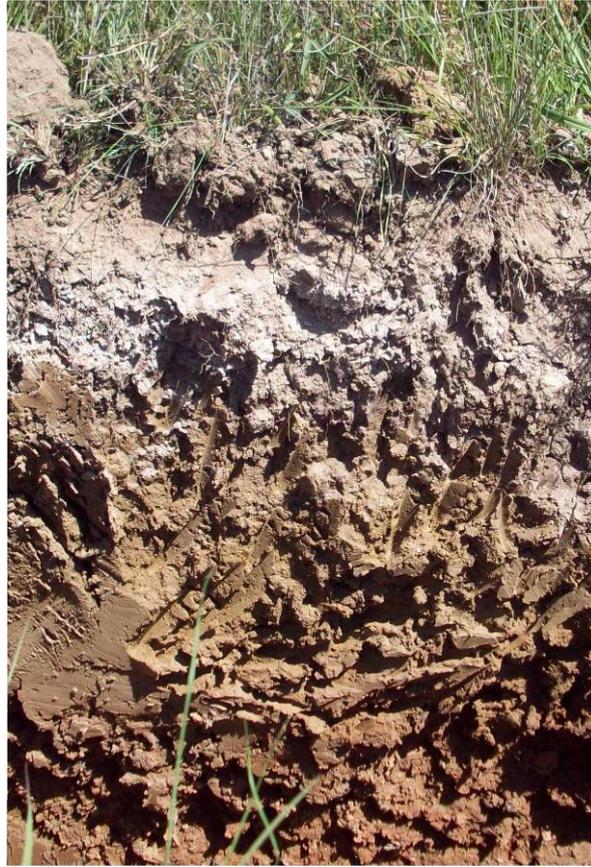
B22 - yellowish red medium clay

C - red and white mottled siltstone

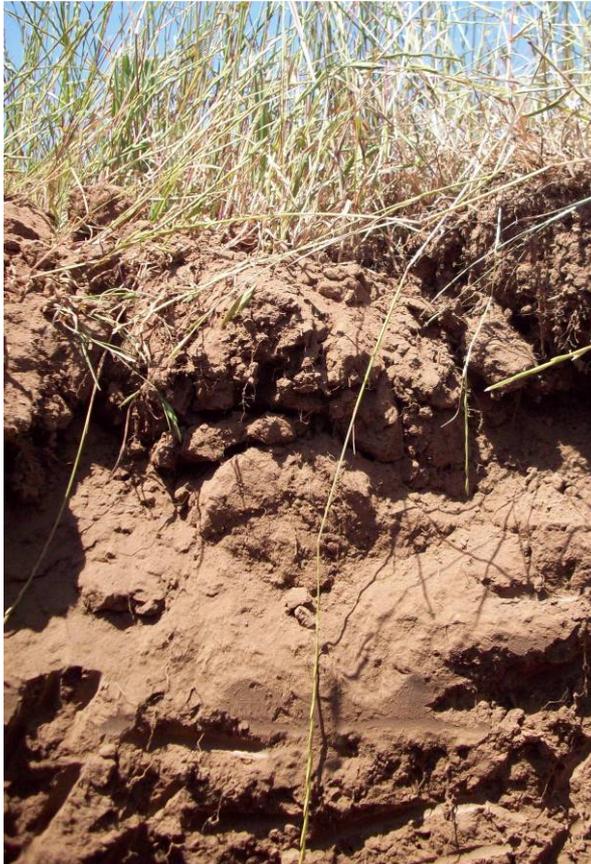
Plate 4. Soil test pit 89.

Brown Sodosol (creek terrace)

A - dark brown loam

B - dark brown medium clay overlying brown clay loam; light clay and sandy clay loam

A clear distinction was observed between the Brown Sodosols of the midslopes, lower slopes and footslopes (transportational and depositional landforms of the Permian sediments) and the Brown Sodosol samples collected from the creek terrace (thought to be part of the Hunter soil landscape). The bleached A2 horizon, a characteristic of the soil profiles located on the slopes, was absent in the soil test pits on the creek terrace. Furthermore, a strong prismatic structure was recorded in the top of the subsoil (B21 horizon) of the lower slopes, but was not observed within the test pits of the creek terrace.

Test Pit 89 Landform: Terrace
Soil classification: Brown Sodosol (Db1.12)
Location: Creek terrace, west of road and next to fence (319659E 6403676N)
Surface condition: poached
